Project Name: Las Virgenes (Tapia) WWTP	Address: 731 Malibu Canyon Rd, Calabasas, CA 91302
Polychem Solutions Tech: Drew Hess	Plant Contact: Alex Leu
Phone: 610-347-9017	Phone:
Email: Drew.Hess@brentw.com	Email: Aleu@lvmwd
Mfg Rep: Casey Rebmann	Org: Coombs Hopkins/DC Frost
Phone: 760.525.6139	Email: casey@chcwater.com
Date on Site: 7/21/22	Tank(s) Inspected: Secondary Tank #3

Professional Summary:

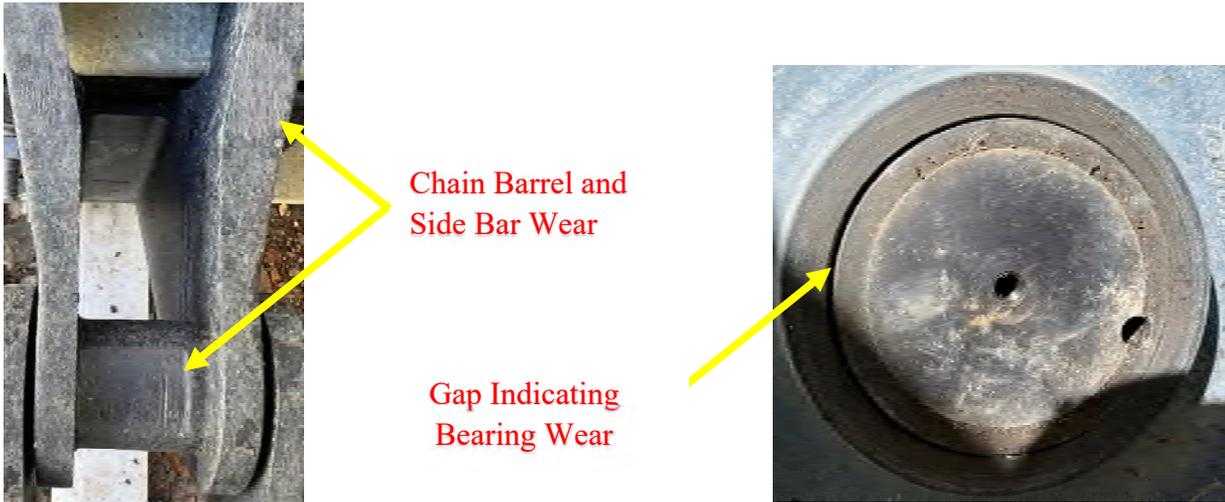
Starting with 720 collector chain, the barrels have reached the thickness at which we recommend planning on replacing the chain at an average of 1.35" OD. This conclusion was reached by also examining the flight-to-flight distance which gives us the amount of wear on the ID of the barrel. A plumb bob was used to confirm that sprockets were in alignment. All 720 sprockets showed expected

wear and no abnormal wear from misalignment. Stub shaft bearings were inspected and do not need immediate replacement but will require replacement in the near future. It is our recommendation to replace all collector chain, 720 series sprockets, and stub shaft bearings at the same time.

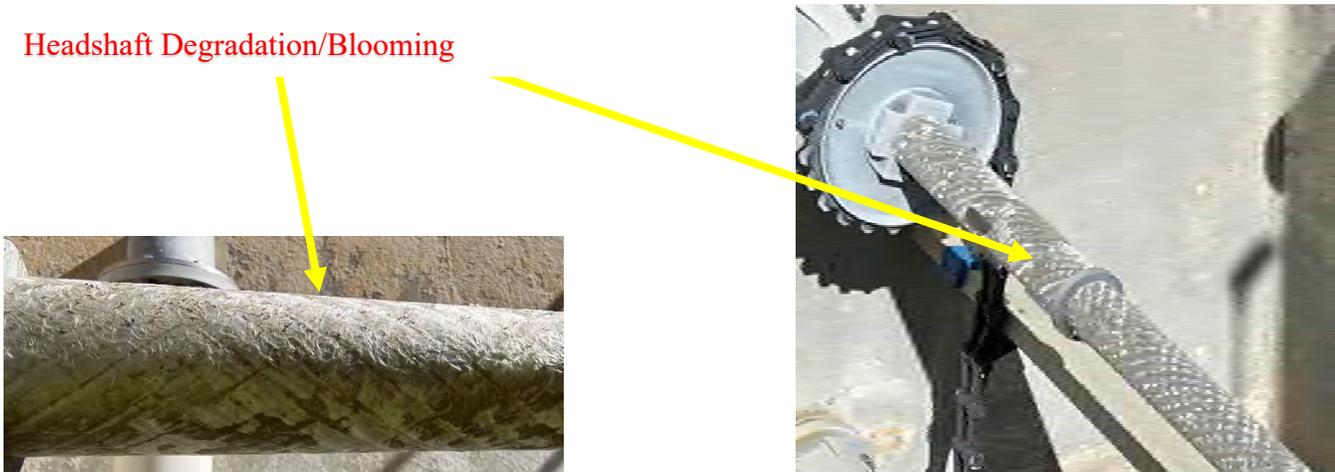
Headshaft tubes showed extreme blooming due to UV exposure and need to be replaced. Polychem FRP headshafts have an UV inhibitor but constant UV exposure over many years will cause a shorter life span. Headshafts that are not constantly exposed to routinely have a 20-30+ year service life. Some plants that have tanks down for extended periods of time utilize pool covers over the headshaft as a permanent solution or simple tarps as a temporary solution. Based off our first inspection, we recommend replacing all 23T 720 series sprockets, only replacing the 40T sprockets that are an older style (Tank #4). The older style 40T sprockets utilized a stainless-steel key that is smaller than the modern nylon key to connect the sprocket to the headshaft. All headshaft tubes will require replacement. So far only Tank #10 was observed to need new NH-78 drive chain.

Headshaft Degradation/Blooming

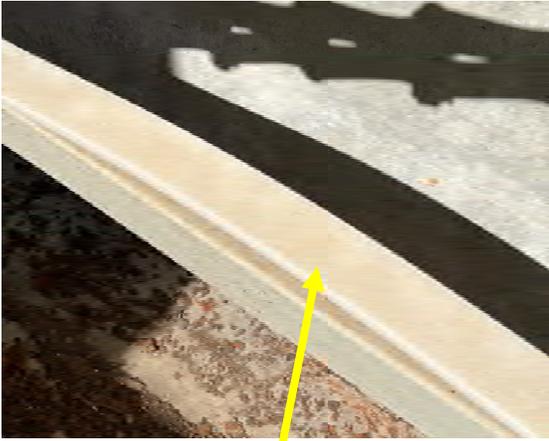
the tank was 1/2" thick and while it has not worn to the point of replacement, it has dried up from UV exposure. This is visible from the cracking observed. It is recommended to replace flights, wear shoes, filler blocks and wear strip. Wear shoes could be reused but it would be a much more labor-intensive process. Typically, flights are assembled above deck with wear shoes, filler blocks, and attachment links and lowered into the tank to make the installation proceed quickly and smoothly. If reusing items, it is crucial to communicate with contractors/maintenance staff which items are being reused so they are not thrown away increasing the timeline until the tanks are back in service.

Cracked and Warped Wear Strip

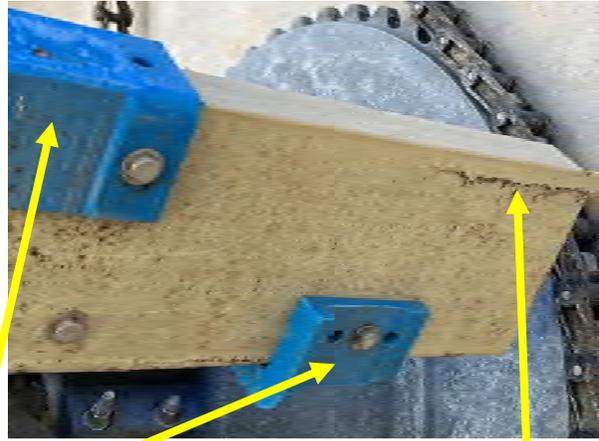
The flights in this tank have reached the end of their usable life. Along with wear from normal usage, flights in this tank showed blooming from UV exposure, cracking from contact with the old rusty T-rail and wear from contacting the bottom of the tank. From above deck it appears that all empty tanks have flights that are also showing blooming except number #4. Some wear shoes in #3 had been flipped so they have about 50% life left. The blue shoes present in the plant are NSF certified wear shoes designed for water treatment plants. Polychem now has black wear shoes specifically designed for wastewater plants that have a lubricant in them, increasing their lifespan. These black wear shoes also come at a cost savings since they do not have to go through the stringent NSF certification process. The wear strip in

Worn Wear Shoes

Cracked and Blooming Flight

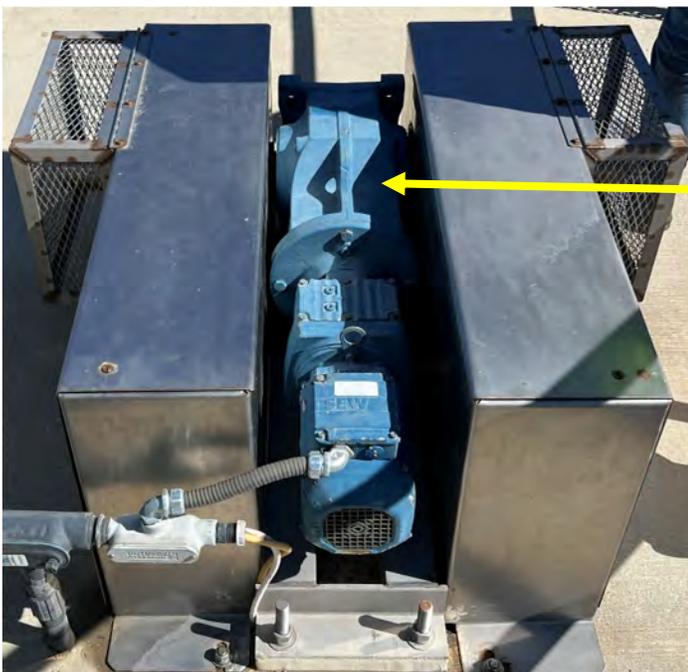
The drive and gear box on this tank was a newer style dual drive equipped with torque limiters. Drives, torque limiters and drive chain are newer and do not require replacement in this tank. There were two drives noted that did not match the newer dual drives. They were on tanks #1/2 and #7/8. It was unclear while onsite if they were old spare stock or not. Those drives were in okay condition and do not need immediate replacement.

Older Dual Drive
