HARPER & ASSOCIATES ENGINEERING, INC.

2007 CORROSION CONTROL PROGRAM REPORT (REPORT NO. 2396.00)

**FINAL CATHODIC PROTECTION INSPECTION
WATER STORAGE RESERVOIRS
LAS VIRGENES MUNICIPAL WATER DISTRICT
CALABASAS, CALIFORNIA
JULY-SEPTEMBER, 2006 - 2007**

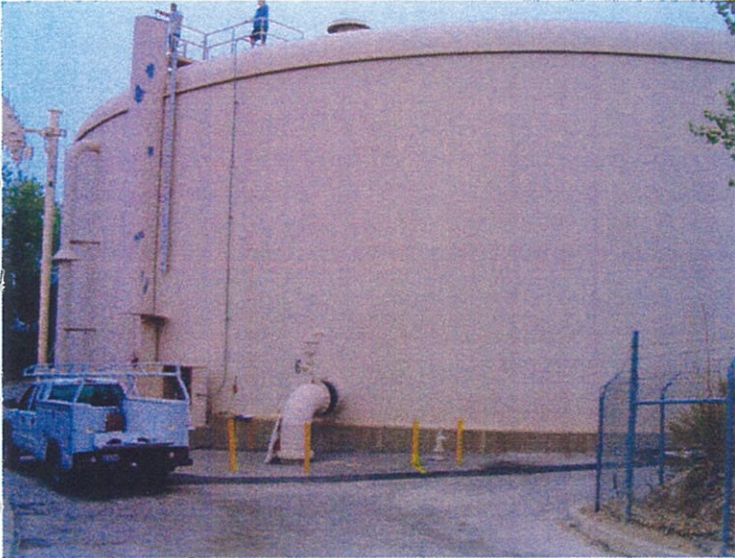
1. Cordillera Reservoir

1. Cordillera (Recycled Water) - Impressed current system - poor meters, poor control, poor anode splices, anodes good, poor reference electrode.
2. Parkway (Recycled Water) - Sacrificial anode system - all new condition, system initially connected during this survey, polarizing as expected, all materials good, should be up to full protection in short period of time.

RECTIFIER - Poor: Meters Not Properly Working, Adjustments Difficult.
WIRING - Splices Poor To Fair Condition.
SUSPENSION - Pin Insulators & Handhole Covers Good (Anodes Good).
OTHER - Cell To Cell Difference: 80 mV.

1. Cordillera – **Replace rectifier, replace all existing anode splices to interior header cable, replace reference electrode**, and have system initialized, adjusted and retested.

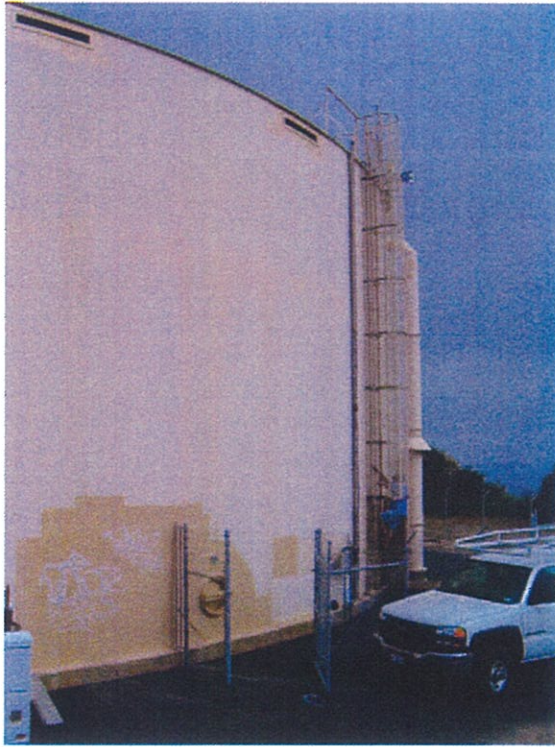
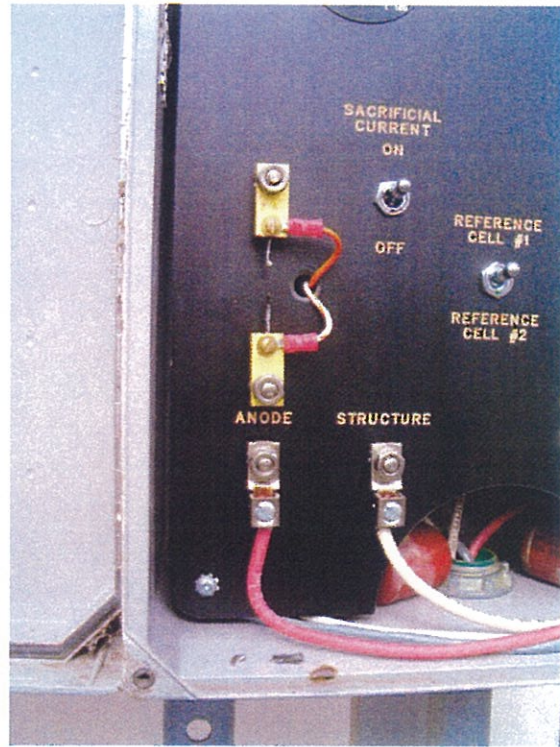
12. Saddle Peak Reservoir

12. Saddle Peak - Sacrificial anode system - found in unprotected condition upon arrival (due to possible lightning strike which apparently destroyed internal meter box shunt), replaced shunt and energized system, left variable resistor in 100% position, tank polarizing, should achieve full protection in short time, should be retested at later time.

RECTIFIER - Meter Box OK, Repaired Broken Shunt.
WIRING - Good, Splices Good.
SUSPENSION - Good, (Anodes Good 90%+).
OTHER - Cell To Cell Reading: Cell #1) 32 mV, Cell #2) 48 mV.

8. Jed Smith #1 – no further action until annual inspection.
 9. Jed Smith #2 – no further action until annual inspection.
 10. Saddle Peak – repaired meter box, system now in operation, should be retested at next annual inspection.

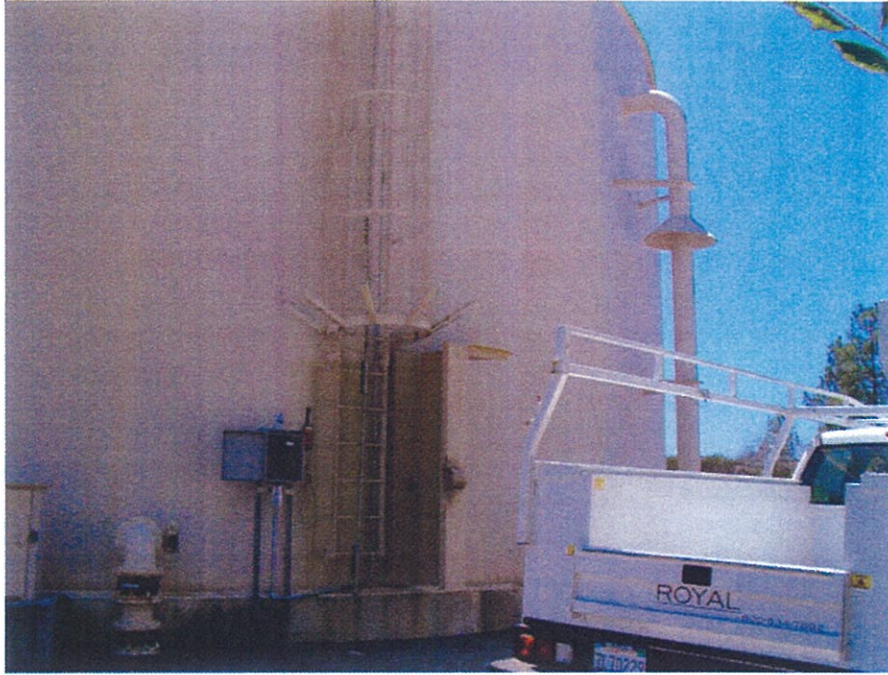
15. Dardenne Reservoir

15. Dardenne - Sacrificial anode system - materials good except for digital voltmeter, which has front crystal slightly cracked, found with protective levels too high, adjusted system by reducing output slightly, presently has full protection.

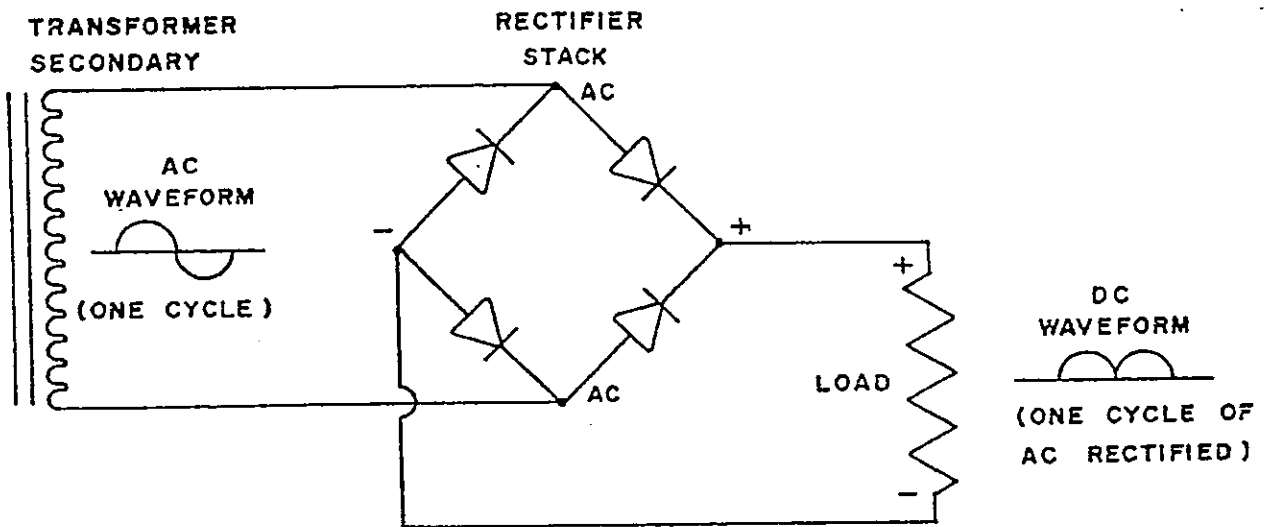
FIGURE 3-5C

RECTIFYING CELLS AND SINGLE PHASE BRIDGE CIRCUIT

By tracing alternating current flow from the secondary winding of a transformer through a single phase bridge stack, it can be demonstrated how rectification is achieved. (Figure 3-5C)

Current leaving one end of the transformer secondary will pass first through one leg of the stack in the direction of the arrow (from an AC stack connection to the positive stack connection), flow through the load, then return to the other end of the secondary winding through a second stack leg in the direction of the arrow (from the negative stack connection to the other AC stack direction). This completes one-half cycle of AC rectification. During the second half of the AC cycle, current will flow in the opposite direction in the transformer secondary and through the remaining two legs of the stack in the direction of the arrows, with the current passing through the load in the same direction as before, resulting in two pulses of DC current in the load for each cycle of alternating current in the transformer.
