**Informational
Public
Workshop:**

Malibu Creek & Lagoon

TMDL & Process & Next Steps

May 1, 2013

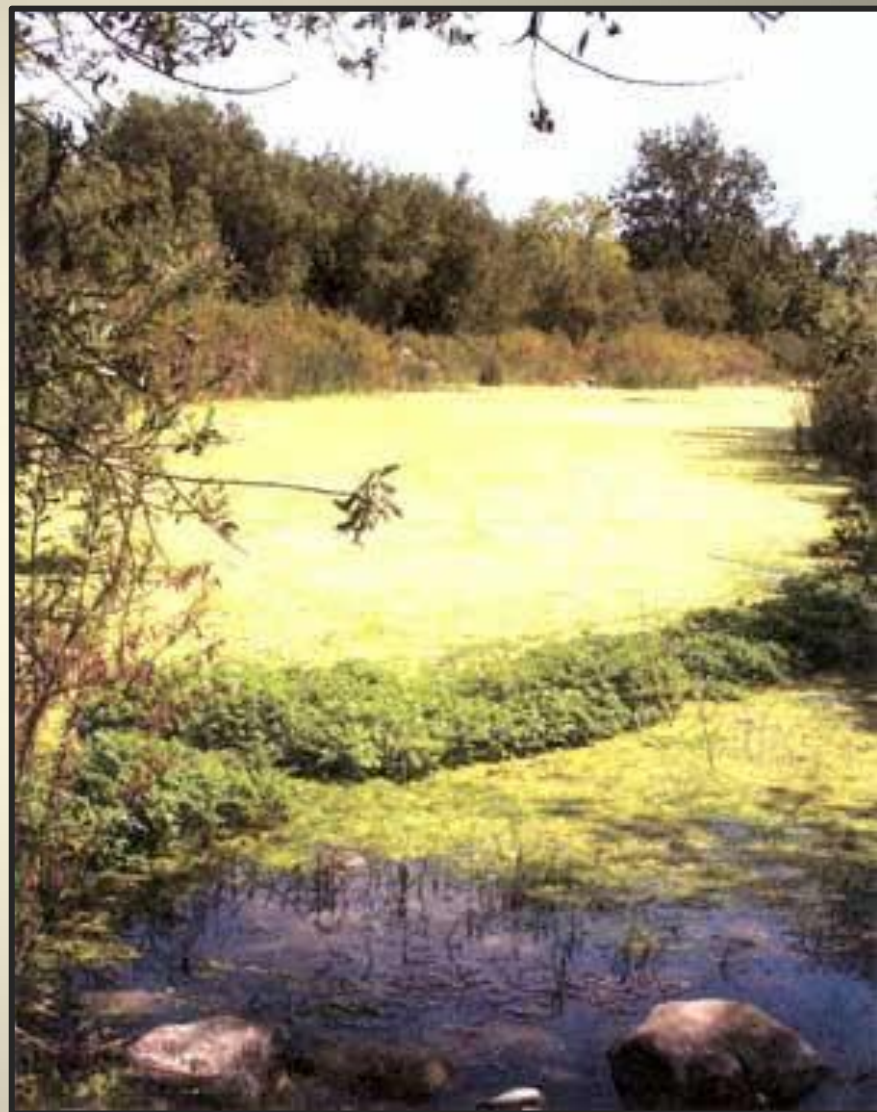
**Malibu Creek
Algae coverage**

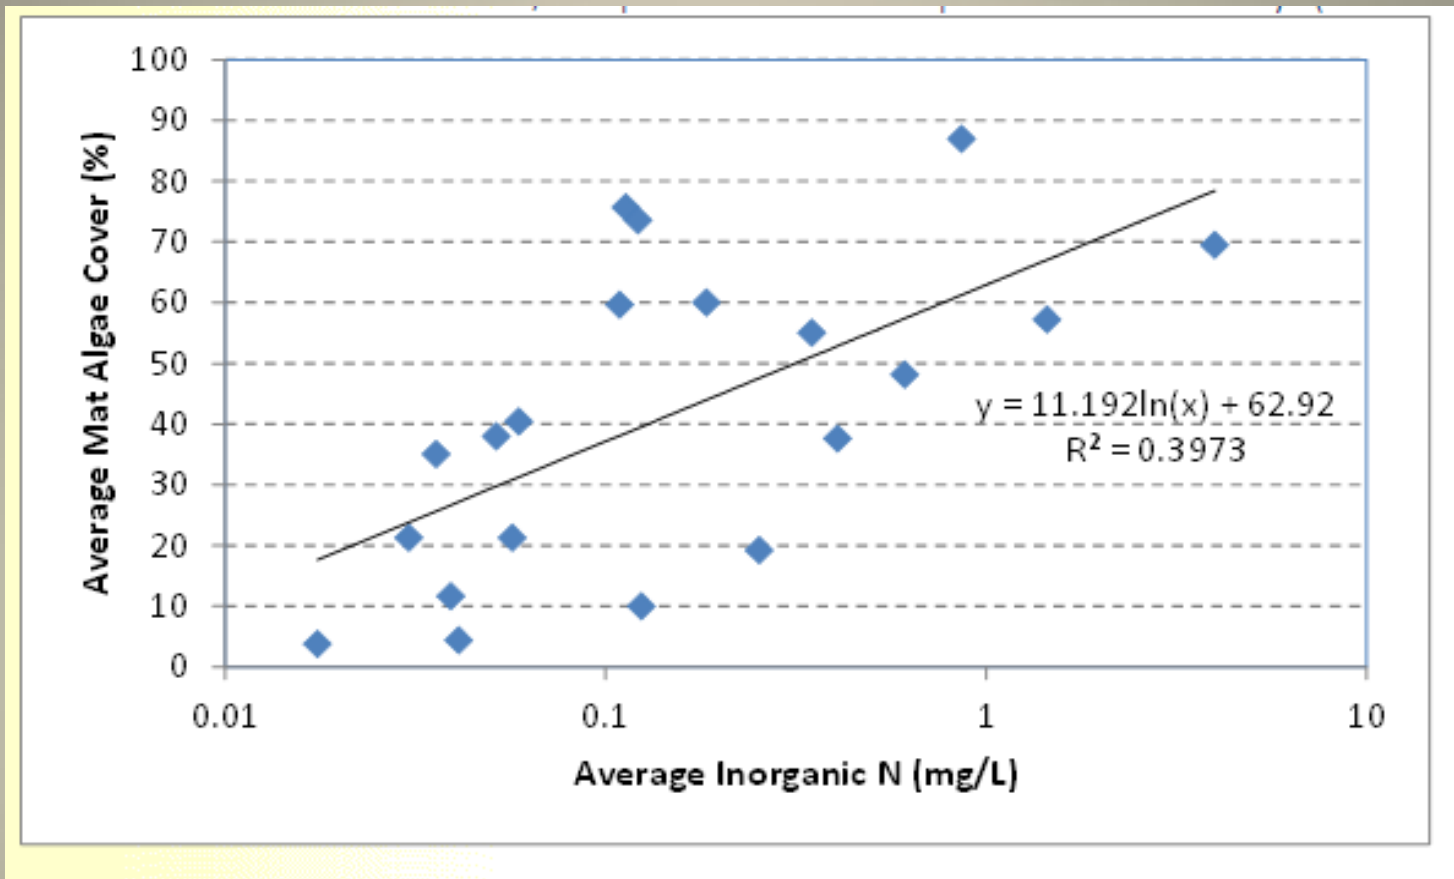
Increasing Nitrogen leads to higher % Mat Algae Cover

Focusing on the growing season between June and September
