Applied Earth Sciences
Geotechnical Engineers
Engineering Geologists
DSA Accepted Testing Laboratory
Special Inspection and Materials Testing

Subject: **Geotechnical Response to City of Agoura Hills Review Sheet Dated April 18, 2014, Senior Housing Community, Vesting Tentative Tract Number 71742 (APN# 2061-001-025), 30800 Agoura Road, Agoura Hills, California.**

1. INTRODUCTION

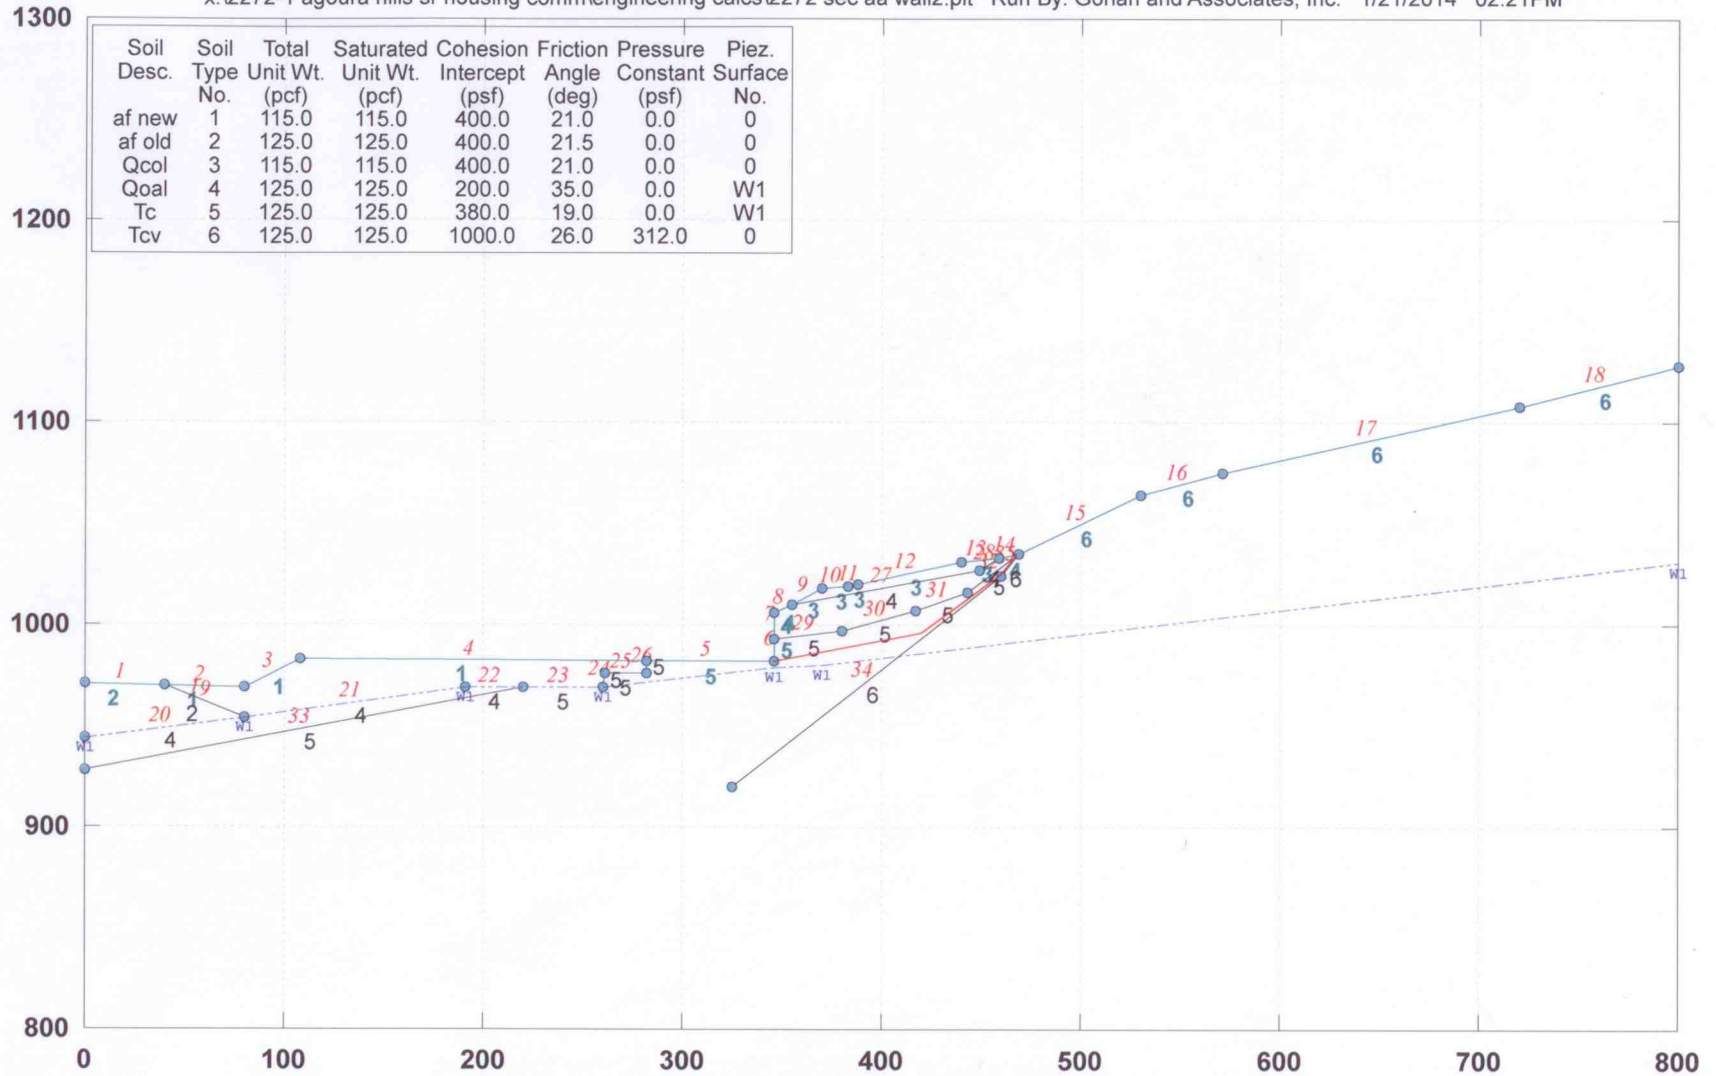
WO 2272-1-0-101 Section A-A'

GSTABL7 v.2 FSmin=1.51

Factor Of Safety Is Calculated By The Simplified Janbu Method

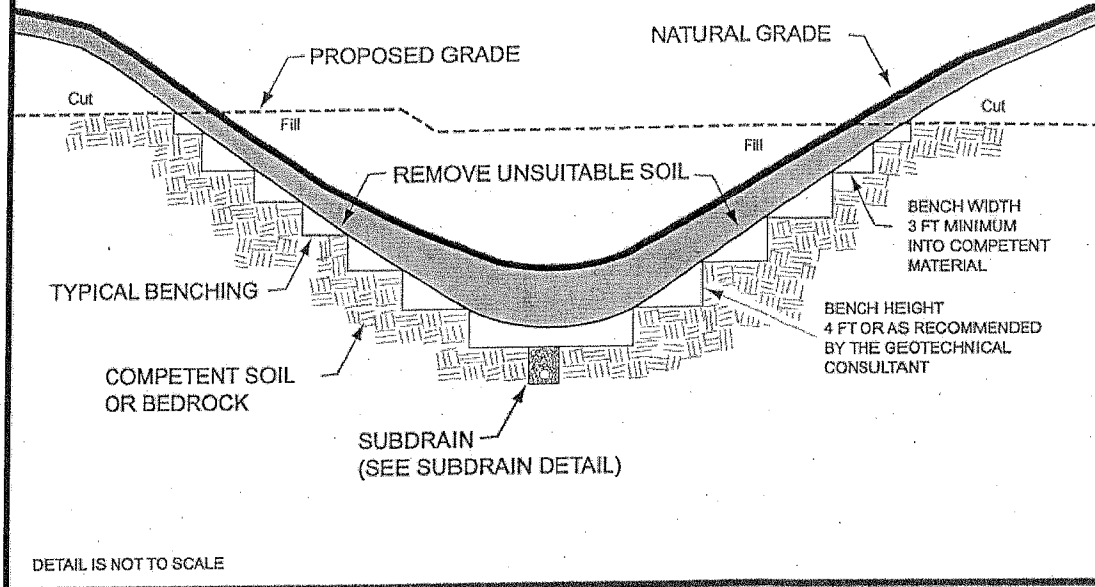
CANYON CLEANOUT AND BENCHING

TYPICAL DETAIL

(GENERALIZED TRANSVERSE SECTION)

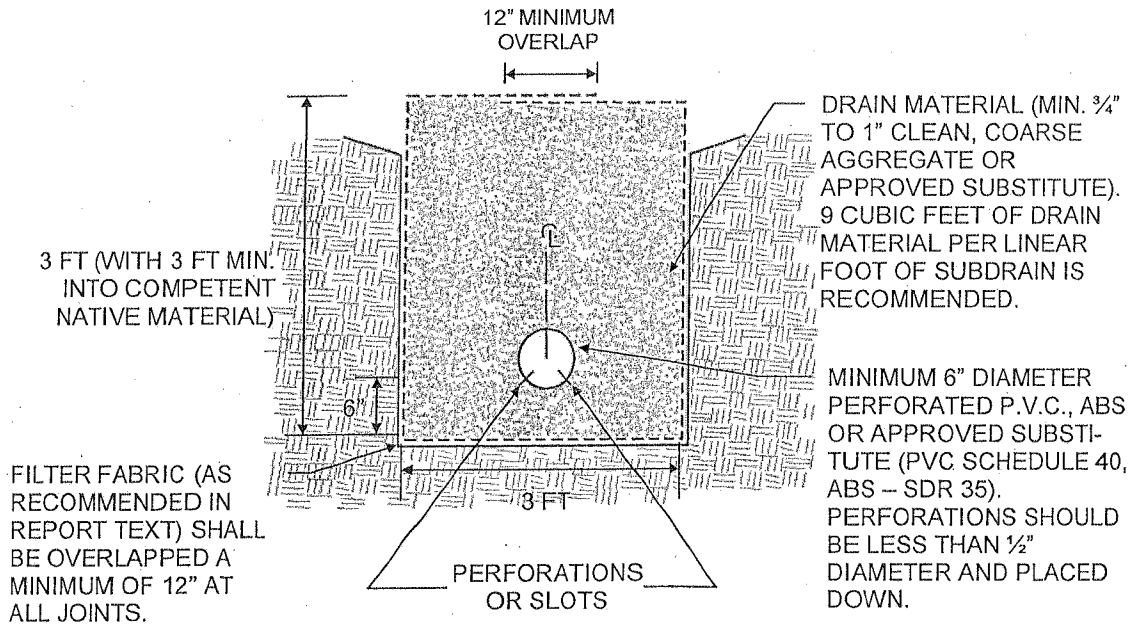
CANYON SUBDRAIN AND CUTOFF WALL TYPICAL DETAIL

NOTE: CUTOFF WALL SHOULD EXTEND MINIMUM 6" BEYOND SUBDRAIN MATERIAL (IN ALL DIRECTIONS)

NOTE: Subdrain pipe should be 6" diameter up to 500 ft long and 8" diameter over 500 ft long. Subdrain pipe should be 10" diameter where up to three 6" subdrain pipes or where two 8" diameter subdrain pipes are confluent unless specified otherwise by the geotechnical consultant. (See soils report)

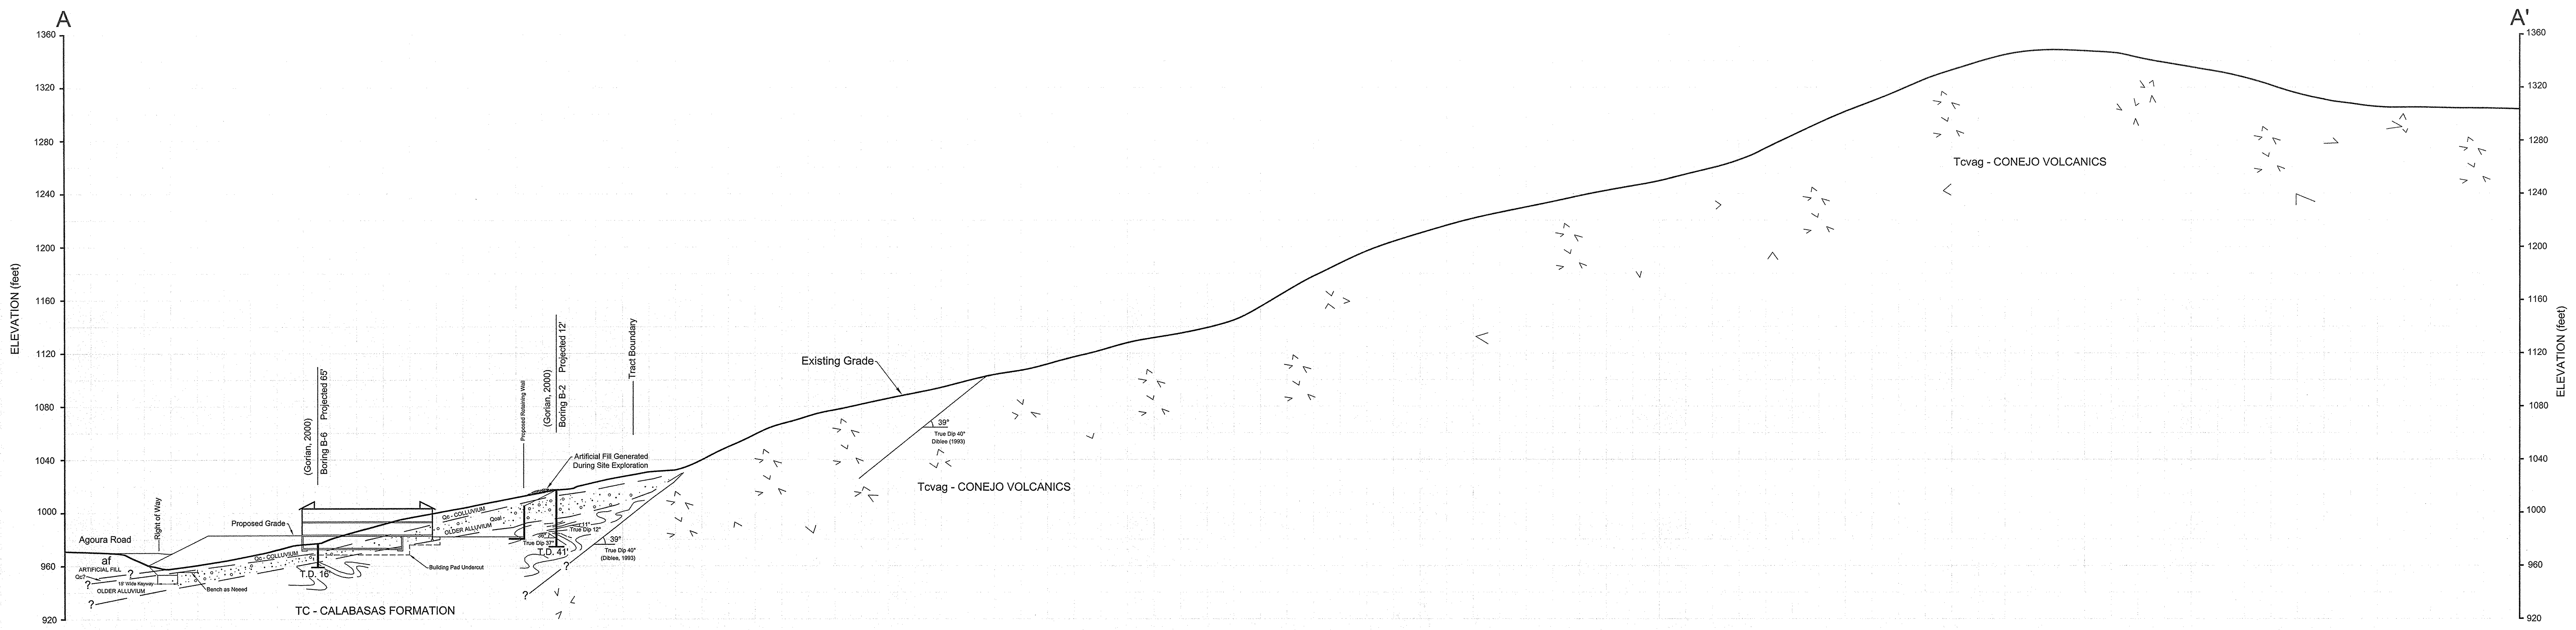
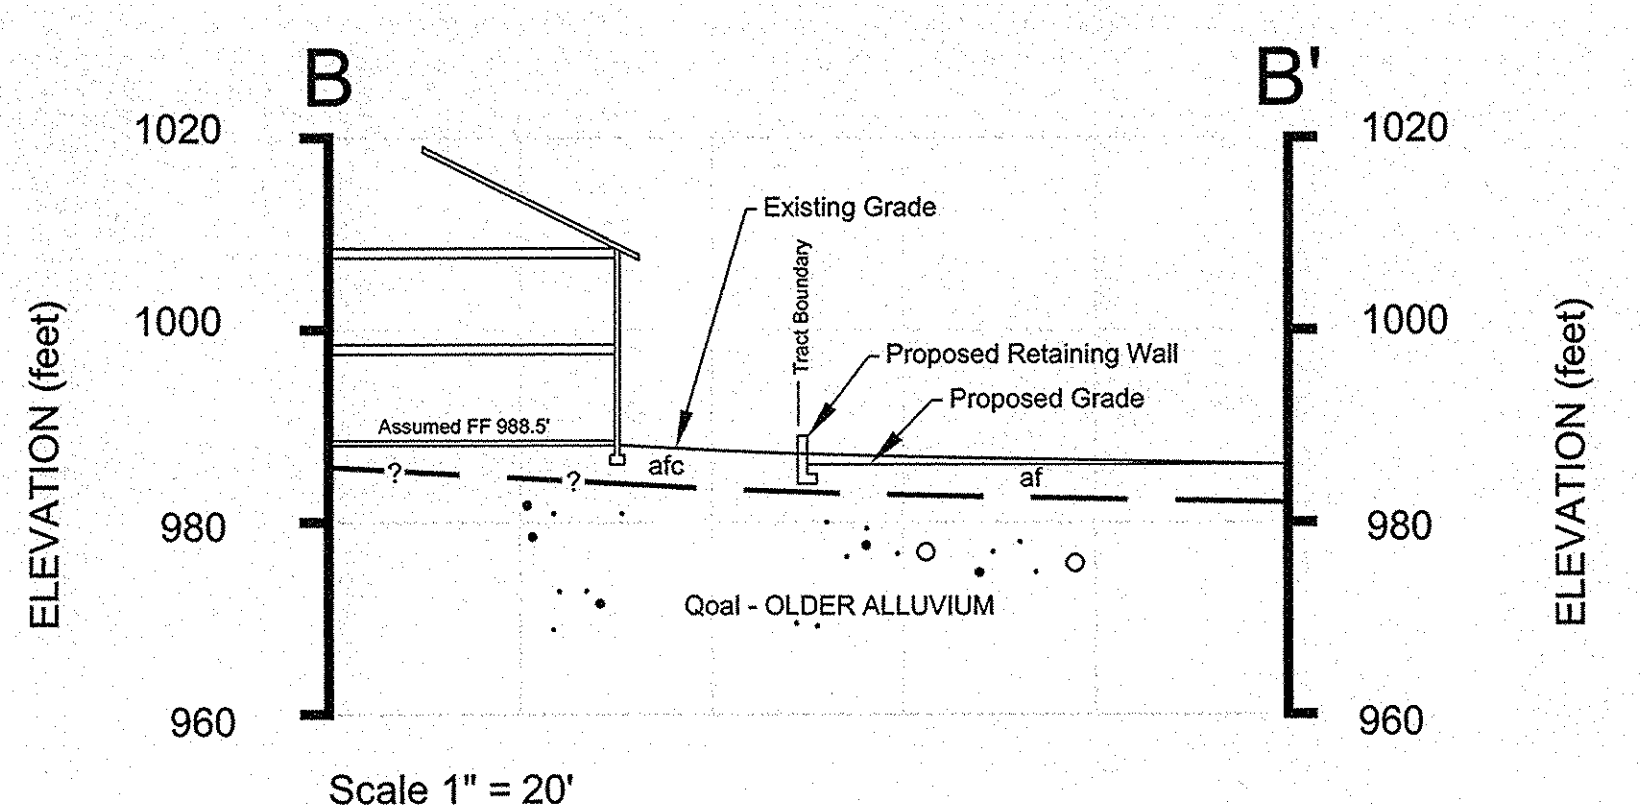
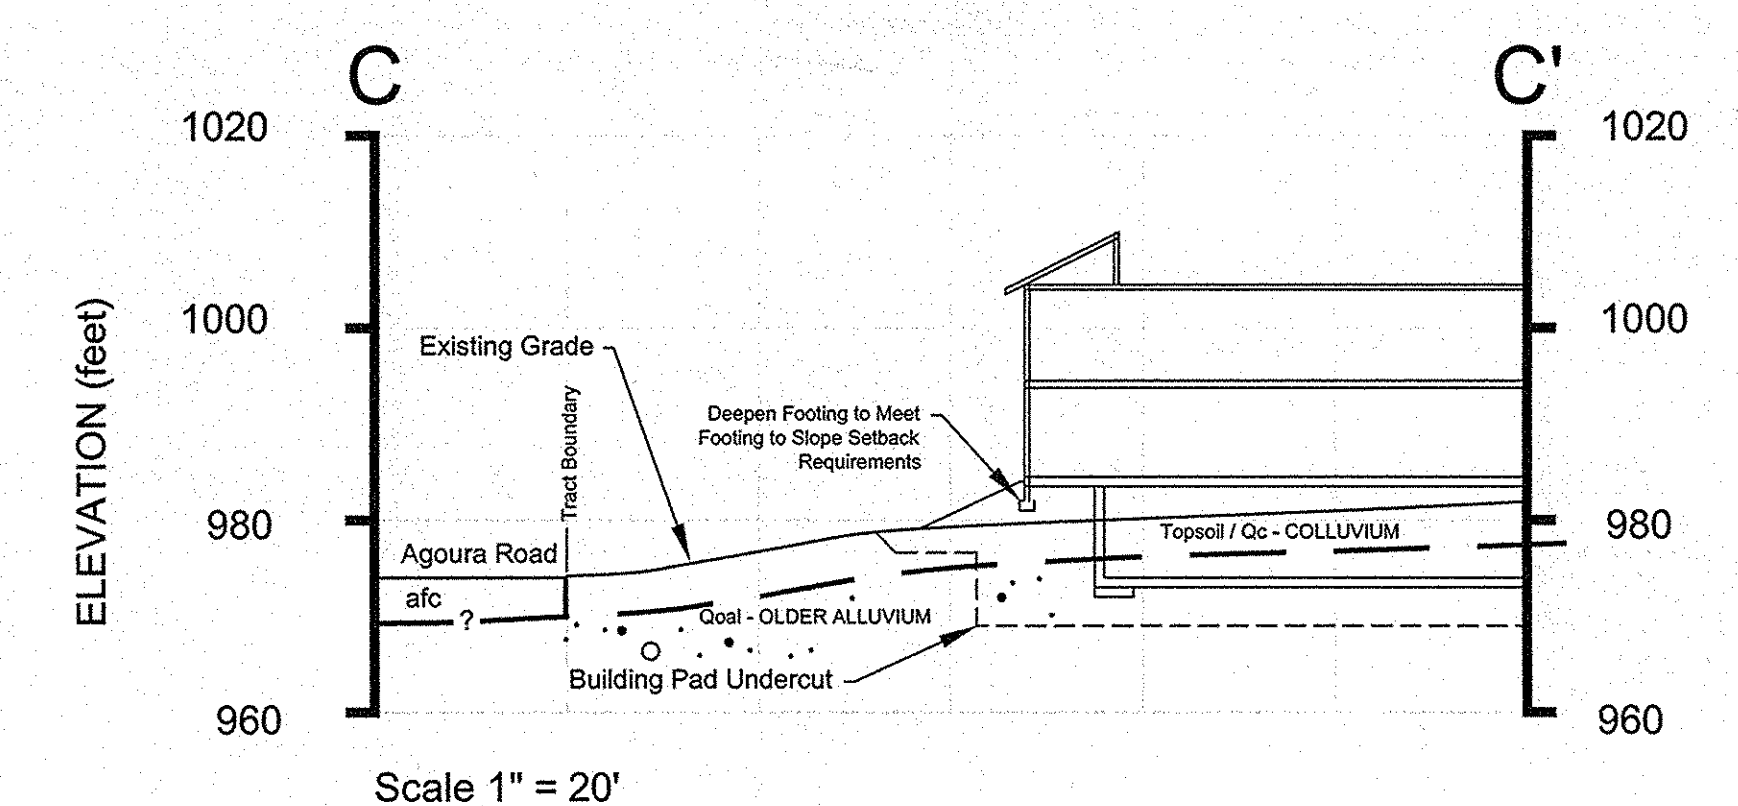
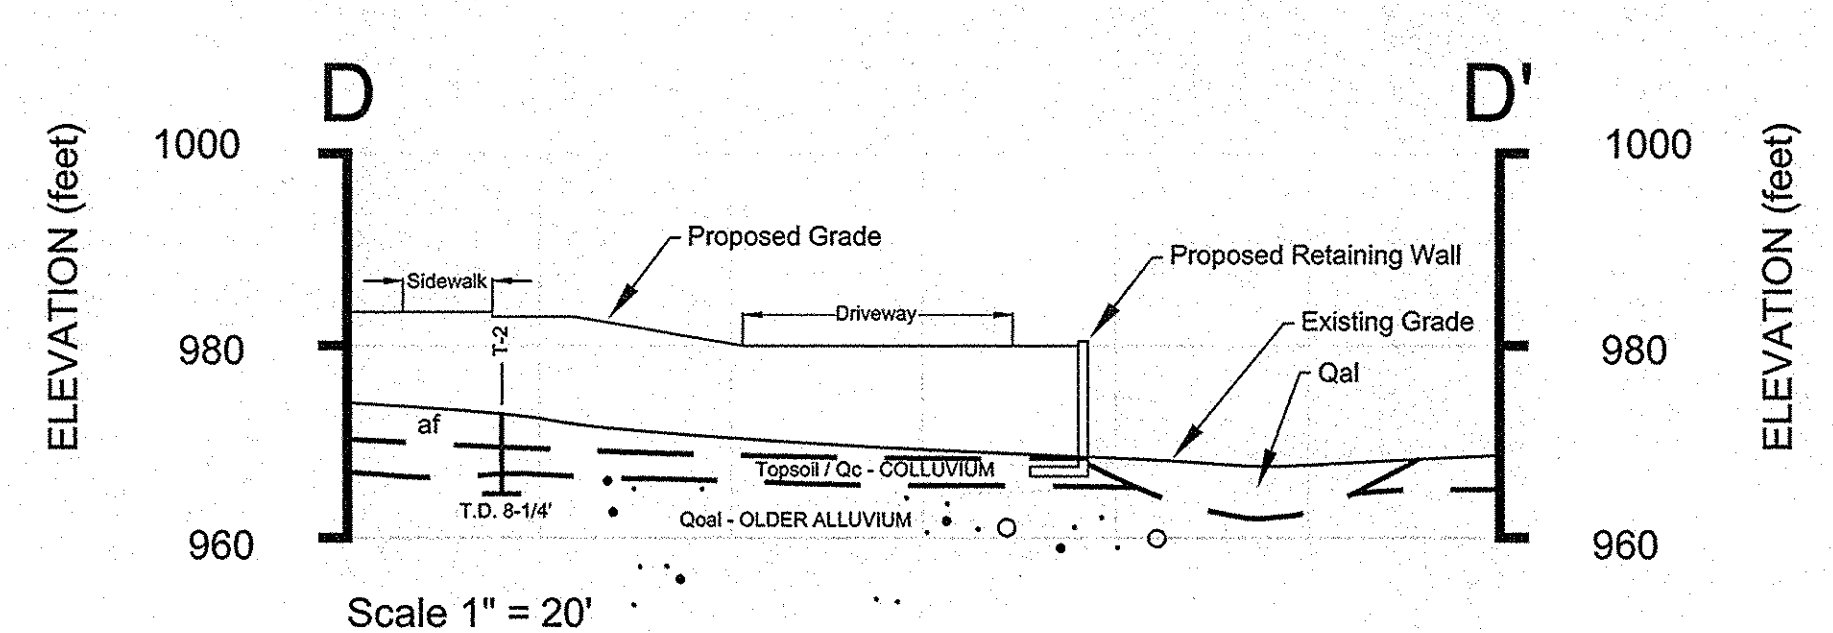
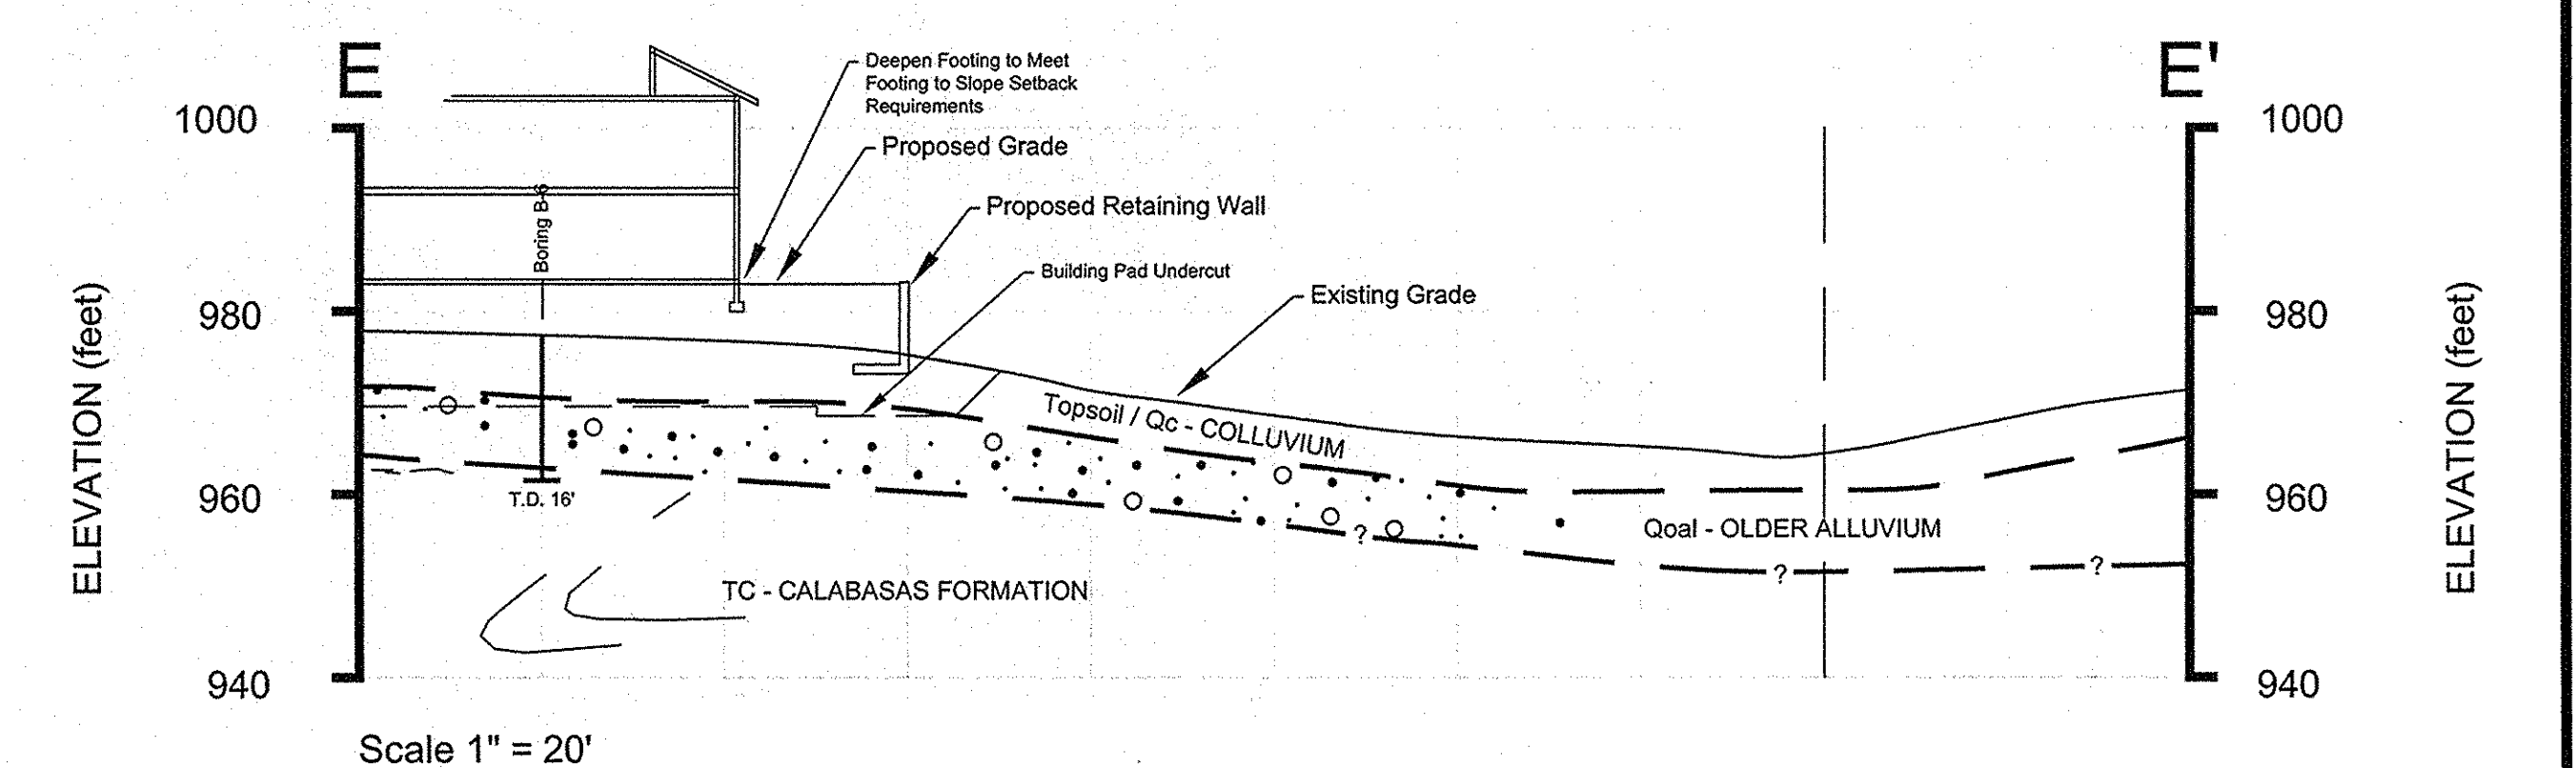
GEOTECHNICAL CROSS SECTIONS

6. The consultant should evaluate the potential for topsoil/colluvium to exert creep pressure on the retaining walls (example: retaining wall in Cross-Section A-A'). Mitigation measures should be recommended as necessary.
