**GEOTECHNICAL STUDY
TWIN LAKES EMERGENCY WATER SUPPLY
PIPELINE
LAS VIRGENES MUNICIPAL WATER DISTRICT
CHATSWORTH, CALIFORNIA**

Prepared for:
Boyle Engineering Corporation

October 2007
Fugro Job No. 3044.064

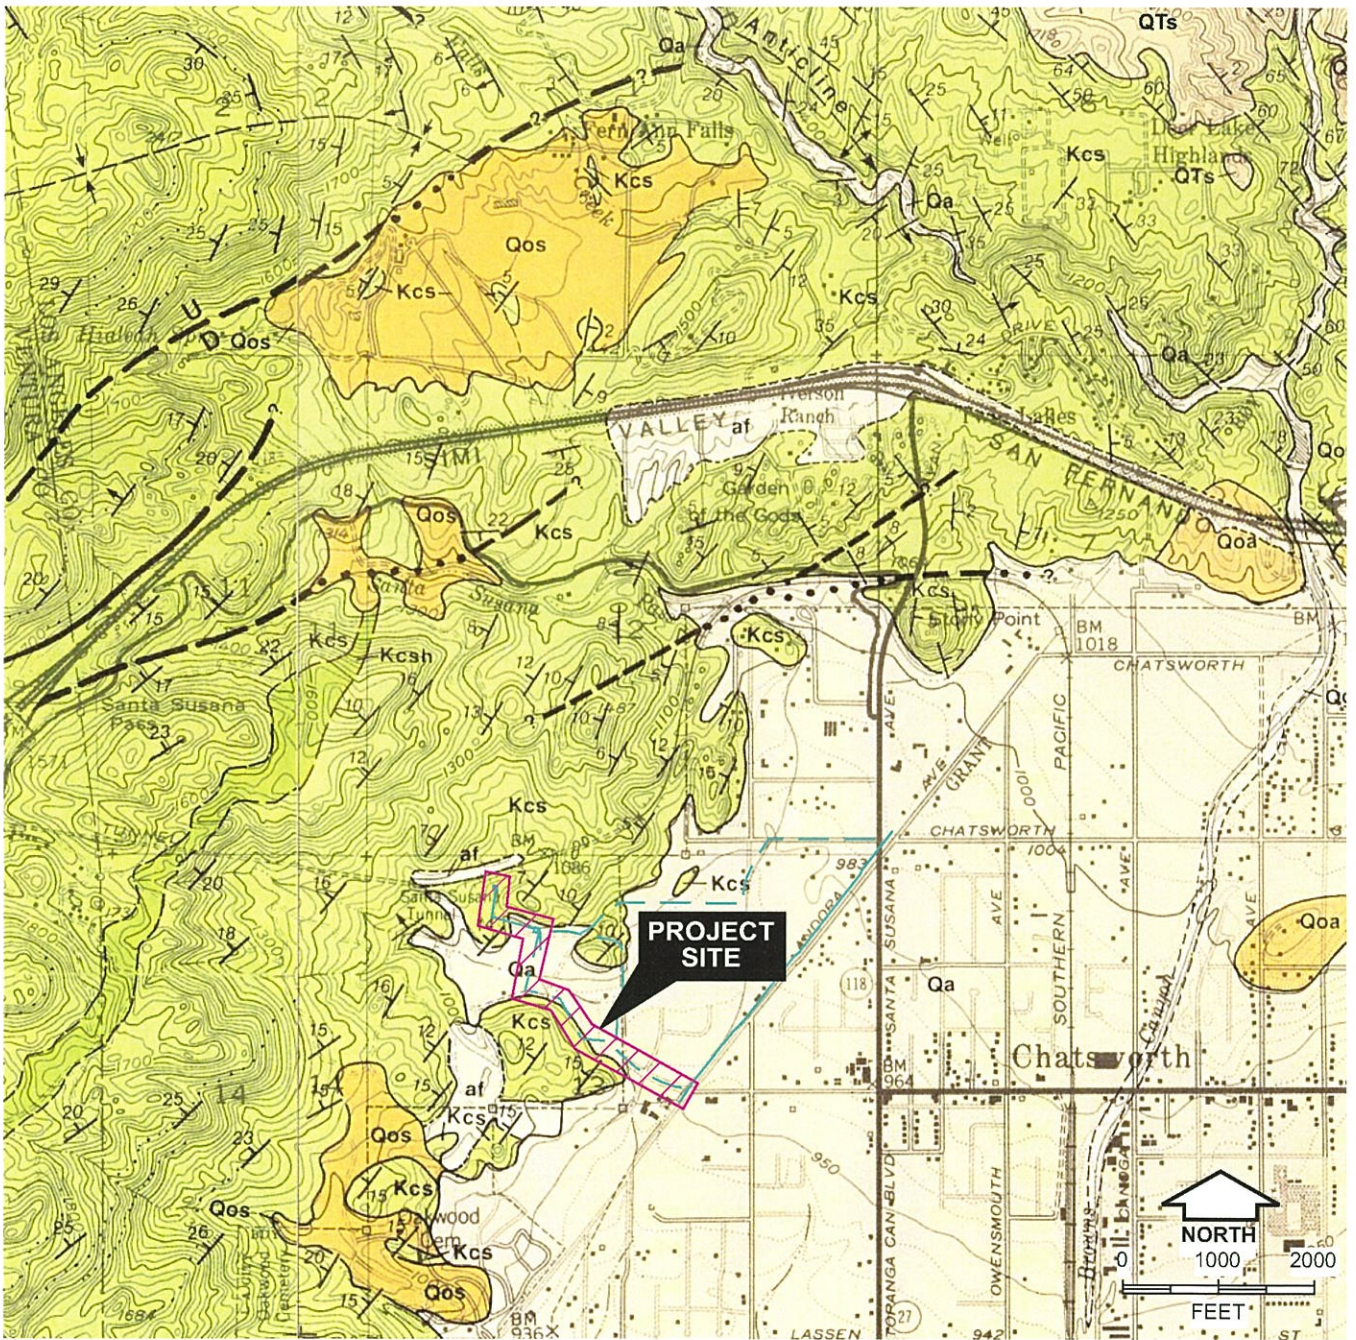
REGIONAL GEOLOGIC MAP
 Twin Lakes Pump Station Emergency Water Supply Pipeline
 Chatsworth, California

Base map sources: Dibblee, 1992a and 1992b.

The proposed pipelines are located within the Transverse Ranges geologic/geomorphic province of California. The province is characterized by east-west-trending mountain ranges composed of sedimentary and volcanic rocks ranging in age from Cretaceous to Recent. Major east-trending folds, reverse faults, and left-lateral strike-slip faults reflect regional north-south compression and are characteristic of the Transverse Ranges. Regional geologic conditions, as mapped by Dibblee (1992a and 1992b), are presented on Plate 3 - Regional Geologic Map.

The pipe alignment is located west of Chatsworth Peak in the Simi hills, about 4,000 feet south of Santa Susanna Pass and the Santa Susanna Mountains, and along the northeastern boundary between the Simi hills and the San Fernando Valley. There are two un-named southwest-northeast trending faults located about 2,700 and 4,200 feet north of the alignment. As mapped by Dibblee (1992a), the earth materials exposed at the site consist of a mixture of fine- to coarse-grained alluvium and bedrock of the Chatsworth Formation as suggested on Plate 3.
